**Banner Desert Medical Center**

**RE: ClimaCheck chiller testing Banner Desert**

Banner Medical - Phoenix  
York YK Chiller Test Results  
June 2015

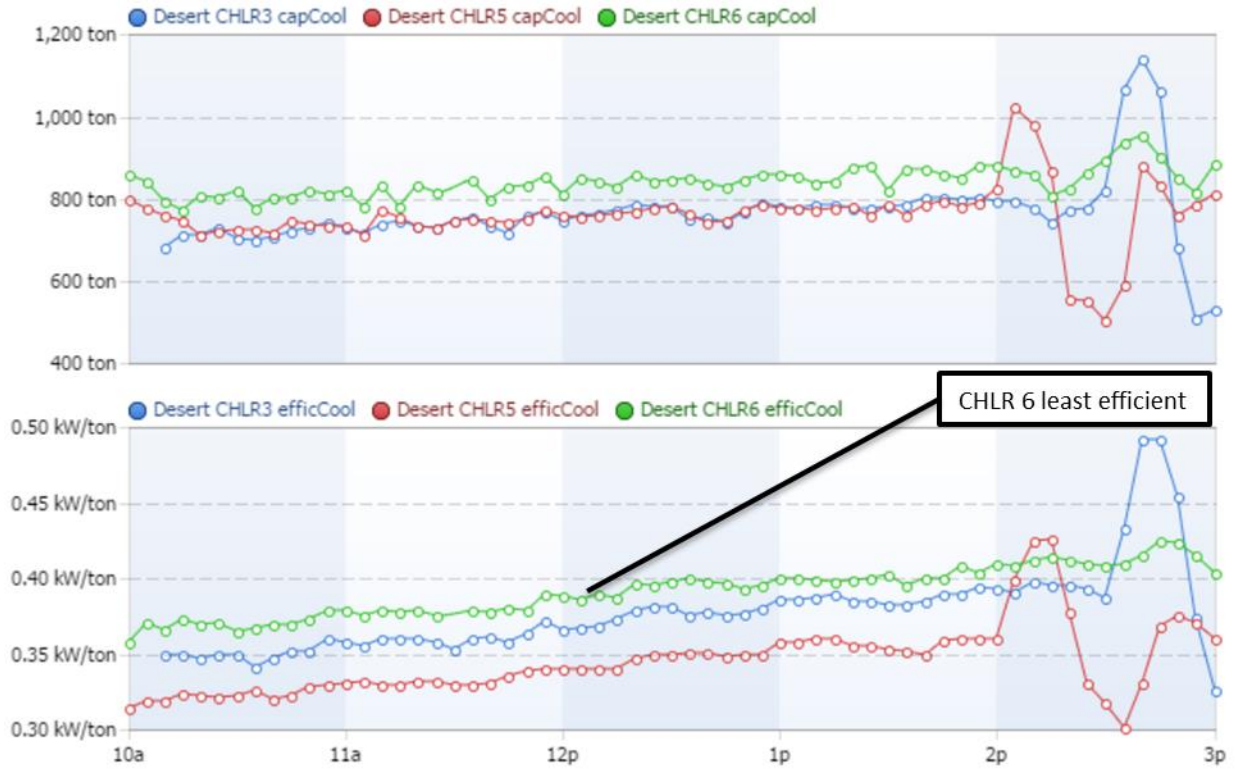
#### 3.1 Chiller 5 is 10% to 15% More Efficient than Chillers 3 and 6

Chiller 5 tested from 10% to 20% more efficient than the other chillers. The issues identified below provide details for these differences.

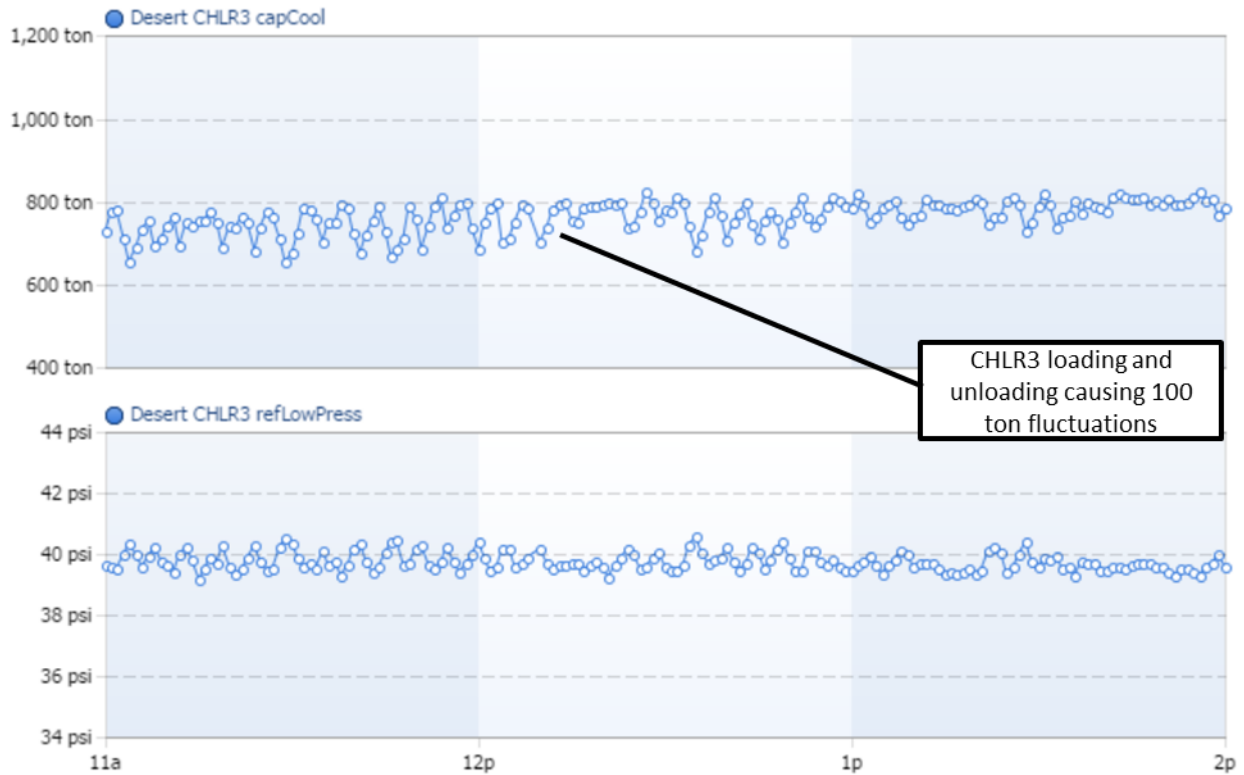
### 3.2 Replace the Chiller 3 Control Board

Chiller 3 needs an upgraded control board. JCI's technician Jeremiah Yanez stated that chiller 3 has an older control board than chillers 5 and 6. This control board doesn't have the processing speed to maintain a constant leaving chilled water supply temperature.

Chiller 3 operated with a cyclic pattern of its inlet vanes opening and closing on a 7 minute cycle. A chiller modulates its inlet vanes as the first response to maintain a constant leaving chilled water supply temperature. With a constant 47°F leaving chilled water supply temperature set point, the chillers delivered water between 46.5°F and 47.5°F. As the VFD speed remained steady, the inlet vanes cycled from full open to around 85% closed.

Replace the control board on Chiller 3 and ensure its control algorithm is tuned to keep the inlet vanes fully open while slowing down the VFD speed.

JCI's technician estimated the new control board would cost \$2,000. Labor for this work is covered with Banner's existing service contract with JCI.

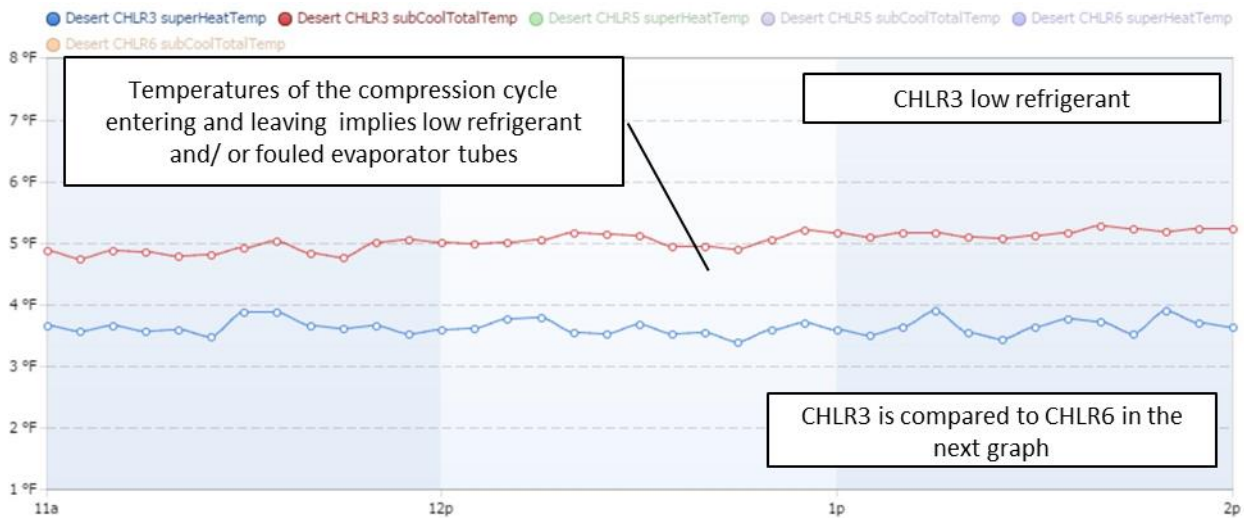
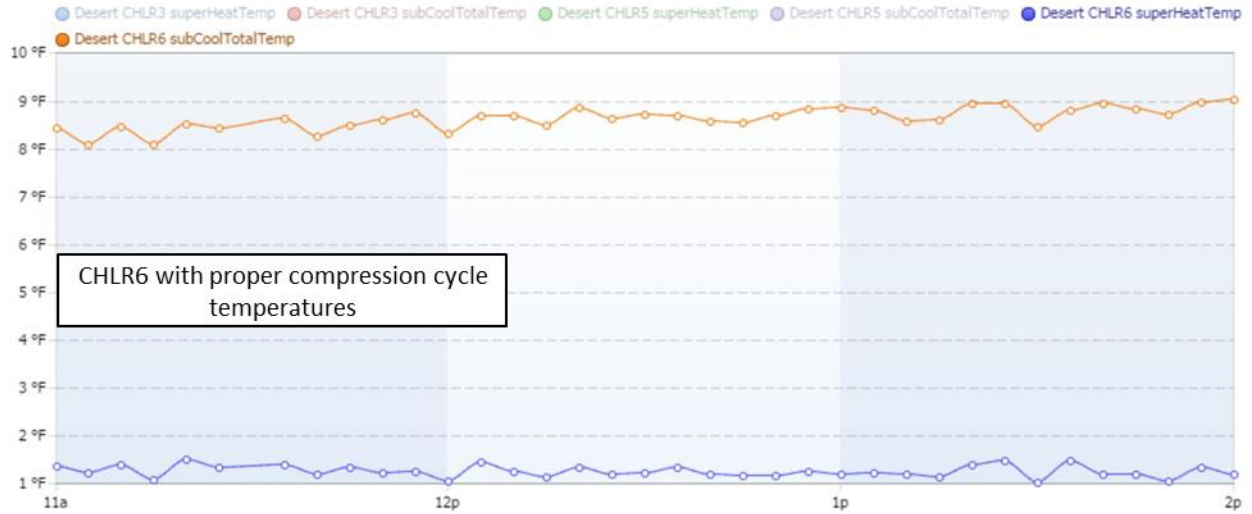
### 3.3 Chiller 3 Refrigerant Level and Evaporator Tube Fouling

- Low refrigerant levels
  - High superheat (~ 4°F) and low sub-cool (~5°F) indicate low refrigerant levels in Chiller 3
  - High approach temp (3.2°F) indicates the evaporator tubes have poor heat transfer (either from scaling or oil on tubes)

- Remove the refrigerant from chiller 3. Weigh the total refrigerant removed and refill the chiller with the required amount.
  - Take a sample of the refrigerant and test for the presence of air and oil.
- During annual maintenance, clean the evaporator barrels.

We estimated the chiller is short 400 lbs of refrigerant and refrigerant costs \$7/lb. We included another 16 hours of labor for tube cleaning.

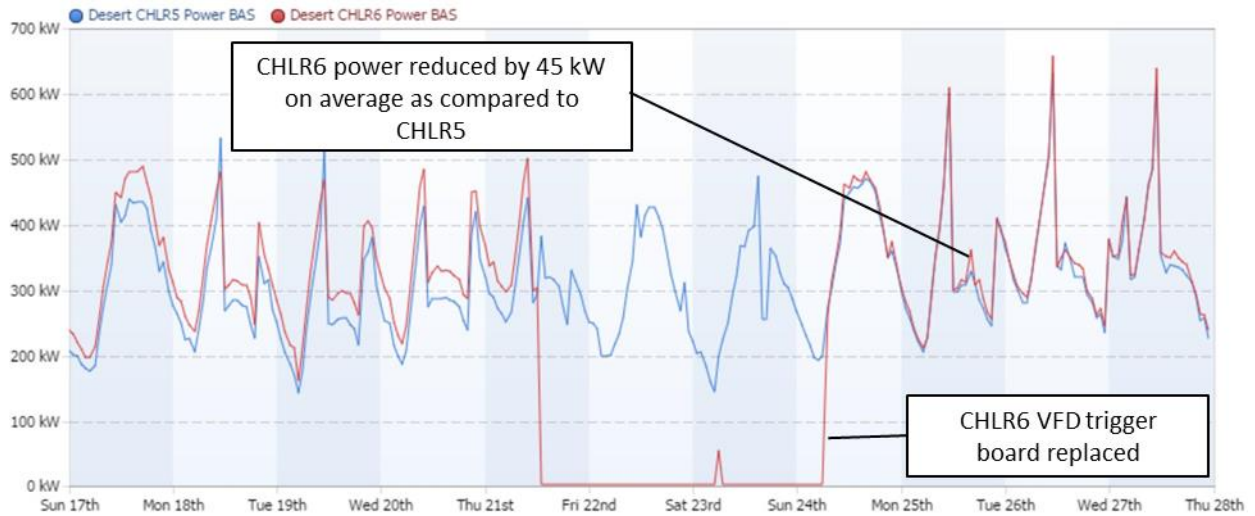
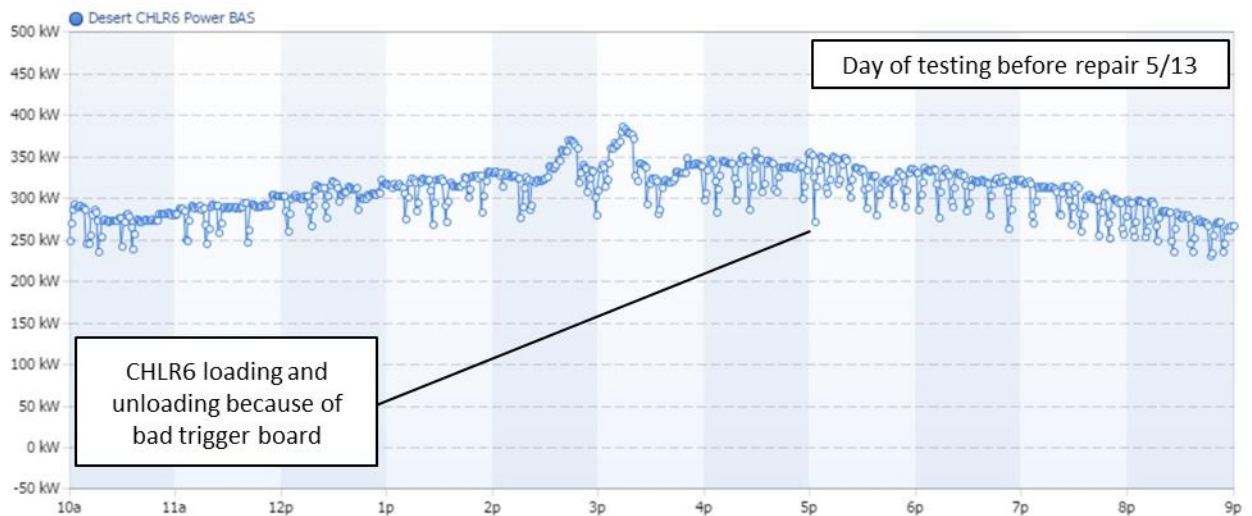
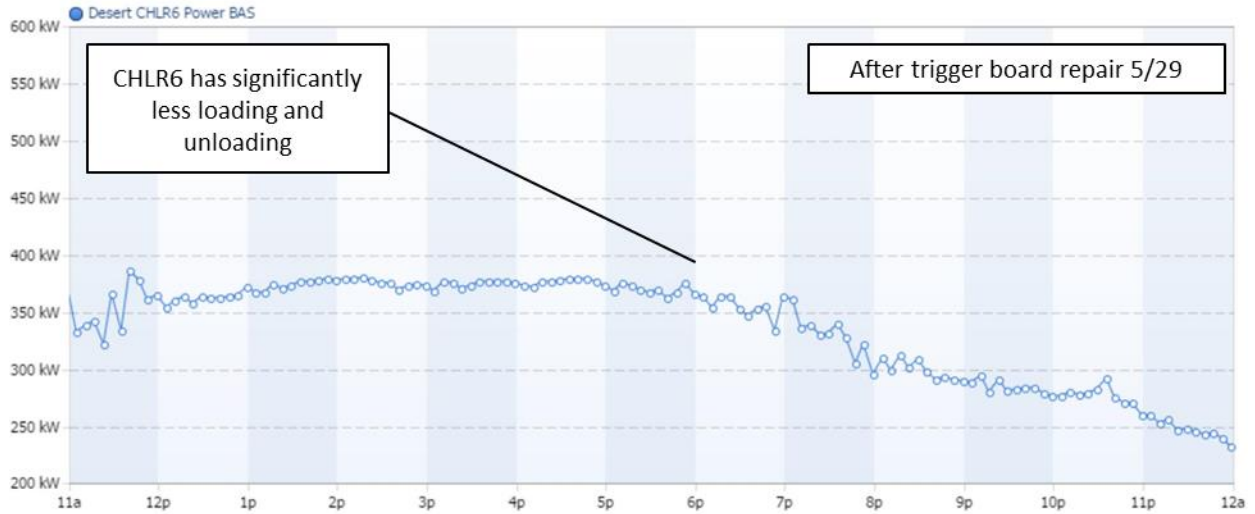
### 3.4 Chiller 6 Trigger Board Replaced

During testing, we observed that Chiller 6 operated approximately 21% less efficient than chiller 5. Shortly after our testing, Chiller 6 failed on a “VFD single phase failure”. Since this time, Banner personnel had JCI fix the chiller. The trigger board was malfunctioning. This has been replaced and chiller 6 now operates at the same efficiency as chiller 5.

JCI has already replaced the trigger board. We estimated that this cost Banner \$2,000.

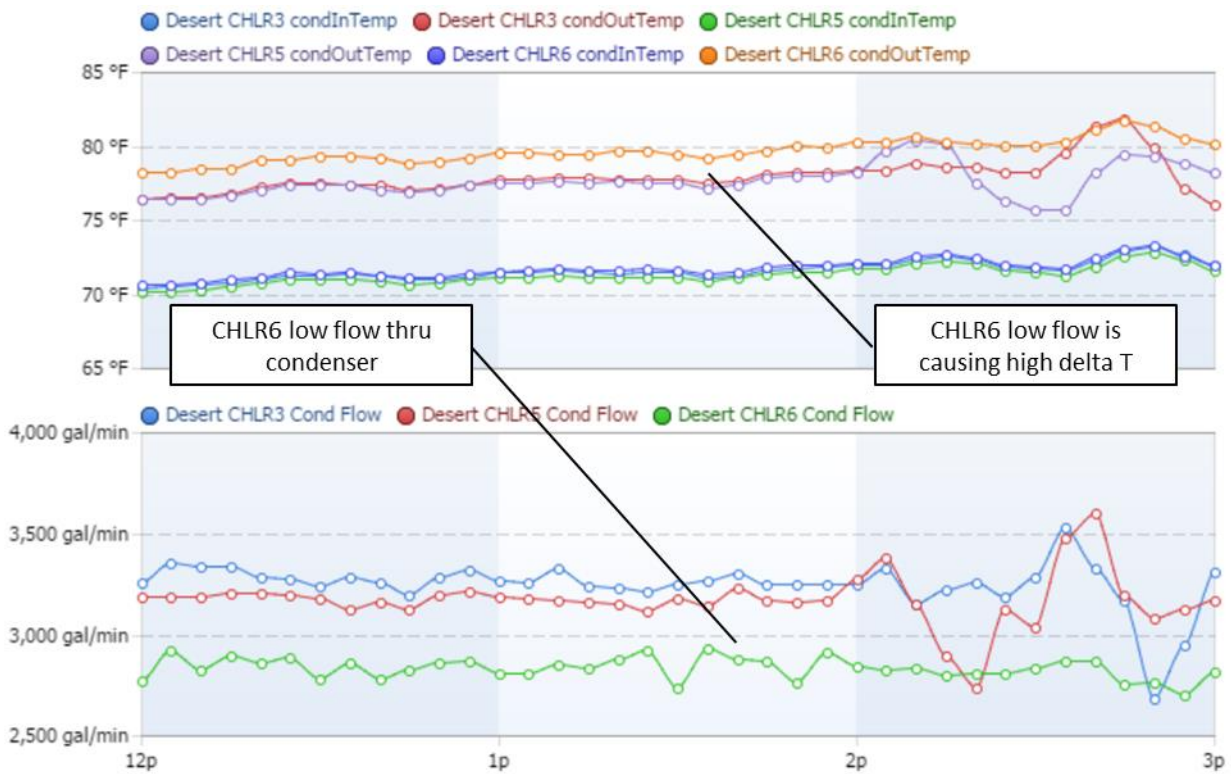
### 3.5 Increase Chiller 6 Condenser Water Flow

Chiller 6 has the highest condenser refrigerant pressure vs the other chillers. This is because it has the warmest leaving condenser water. All of this is the result of Chiller 6 receiving about 14% less condenser water flow than chillers 3 and 5.

All of these chillers have a modulating valve that controls flow through the condensers to maintain a constant 9°F temperature differential on the water in and out with a minimum flow of 3,100 GPM/chiller. During testing, the actual dT was around 6°F to 7°F which meant the minimum flow measurement was controlling the flow.

Calibrate Chillers 6 condenser water flow meter. It currently reads about 14% too low. We have estimated that calibration of the flowmeter will cost \$1,000.

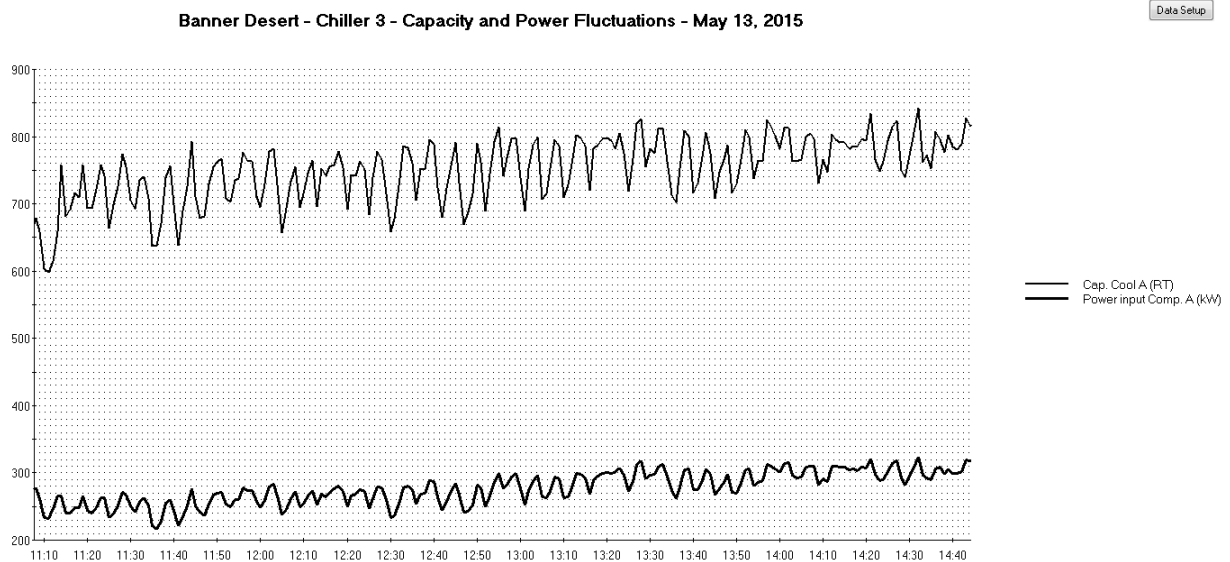
Banner Desert - Chiller 3 - kW/ton Fluctuations - May 13, 2015

The loading of chiller 3 was highly varying. The controls programming should be examined to find the source of these fluctuations. The magnitude of the fluctuations was approximately 100 tons over a period of about 7 minutes from peak to peak. This had a relatively small impact on efficiency in kW/ton as the period was not long enough for performance to change more than

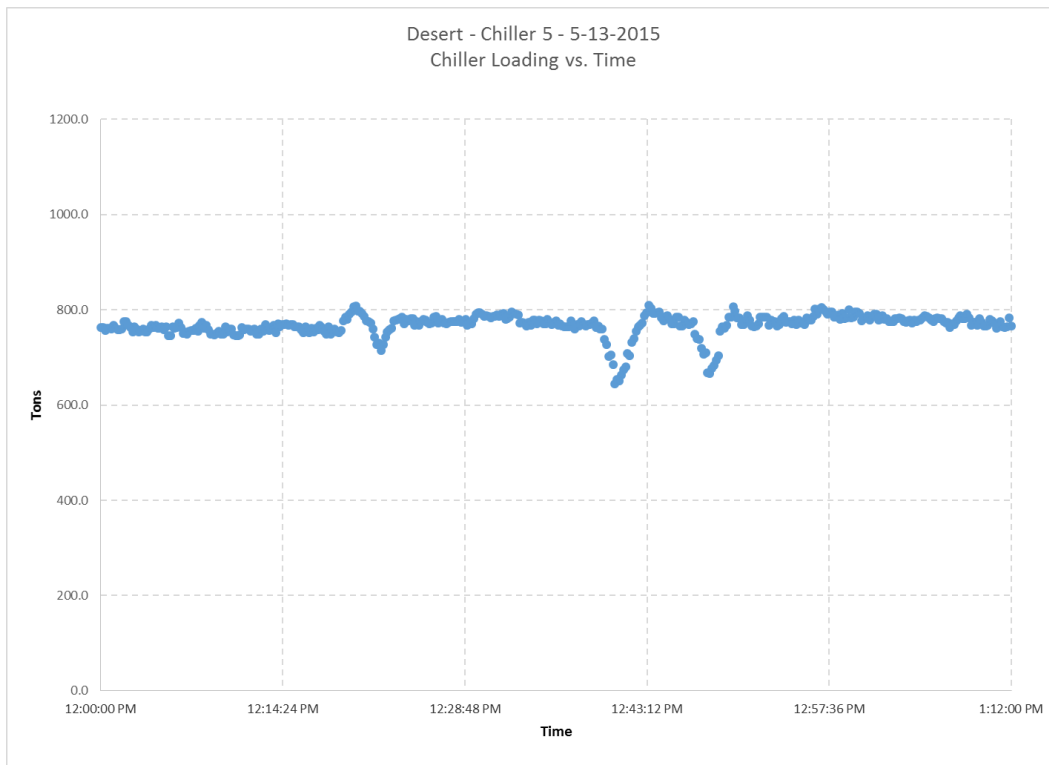
## Desert Chiller 5

Chiller 5 and 6 at Desert also experienced fluctuations in loading though rather than a regular fluctuation these were intermittent short duration 'drop outs'. These could be flow related rather than control signal related since the load is otherwise very stable.

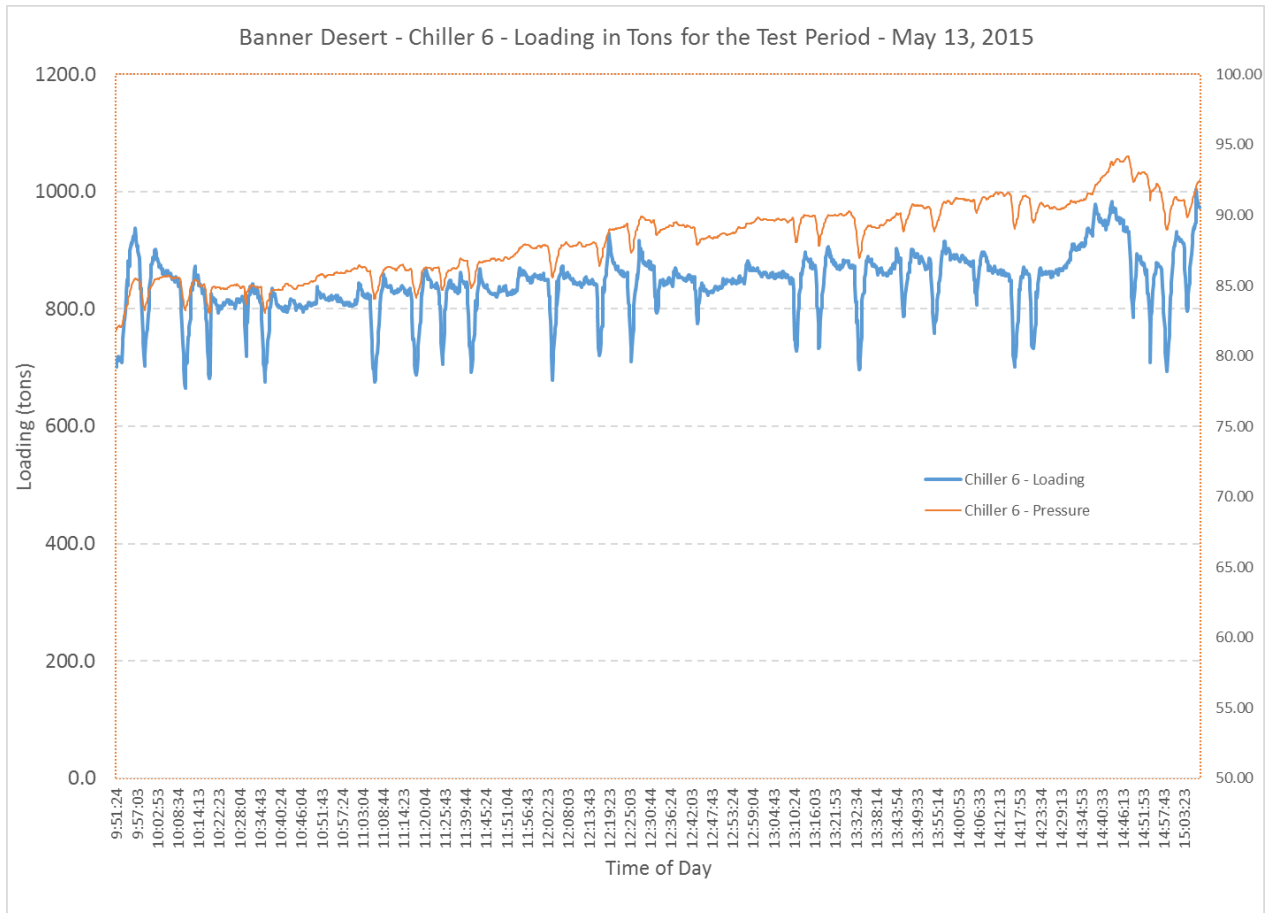
## Desert Chiller 6

A similar pattern of intermittent fluctuations in load was seen in Chiller 6. Chiller 6 was the best performer of the three chillers and did not seem to have any areas of immediate concern except for the loading drop outs. The overshoot that occurs after the drop out does suggest a control system that is goal seeking and is occasionally fooled by bad data, perhaps in the chilled water temperature algorithm? Then it overshoots to get back on track like a typical PID loop. The effect is seen in the discharge pressure.
