ViaSat 6155 El Camino Real Carlsbad, CA 92009 Trane CGAM Chiller Performance Analysis Oct 2016

Tests done by: Sean McCaffery, Emerging Energy Solutions Report published by: Klas Berglof, ClimaCheck Sweden AB

Executive Summary

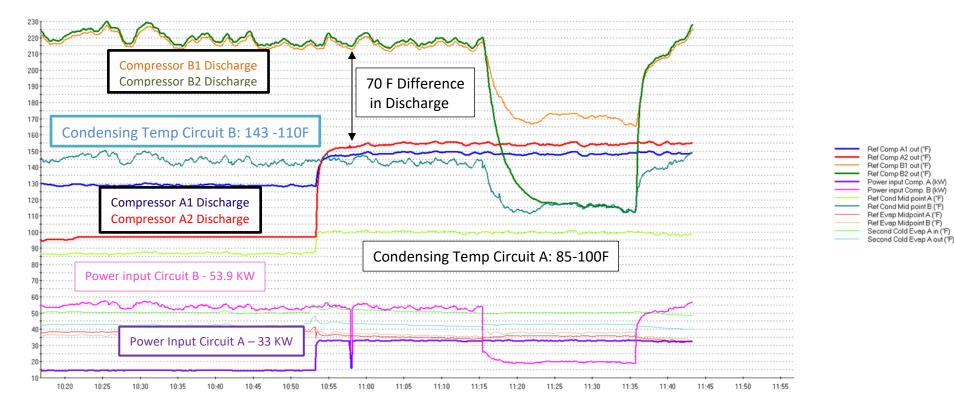
Figure 2 Operation of Circuits A and B March 2016

System is operating stable with some slow fluctuations on discharge. At the beginning of the measurement, compressors A1, B1, and B2 are running. At 10:53, compressor A2 starts to run. At 11:15 compressor B2 is turned off and is later turned back on at 11:36. The following is identified:

- Energy consumption of circuit A is 33 kW, while the consumption of circuit B is 53.9 kW (The equivalent of having 3 comps on Circuit A).
- Discharge on Circuit B is 220 F Circuit A is 150 F. 70 F difference between the two circuits at full load.
- Condensing on Circuit B 143 F Circuit A 99 F 34 F DT

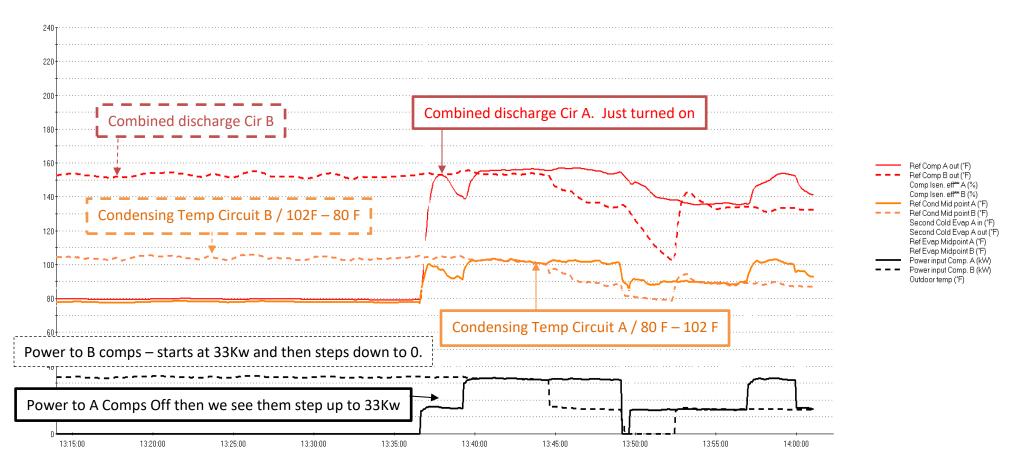
Figure 3 Operation of Circuit A and B October 2016

In graph from October 6th we can see that Circuit B runs almost identical to circuit A.

- Energy consumption is the same **33Kw** on both circuits.
- Discharge on both circuits never goes above 157 F
- Condensing never goes above **102 F** on either circuit.

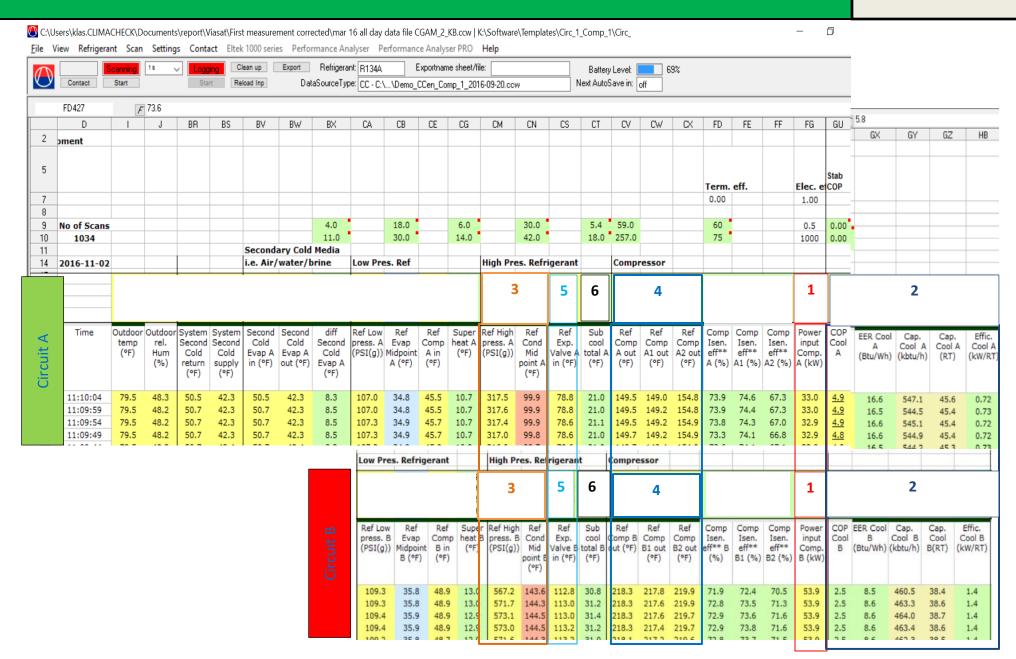
Figure 4 Report Page Circuit A and B March 16, 2016

In the following figure 4, we are outlining the detailed data collected between 10:55am to 11:15 March 16, 2016 and how each component mentioned earlier is affected. There is no room for measuring errors as all measured values marked in individual boxes below are showing the poor condenser performance which include:

- 1. Energy consumption of Circuit A is 33 kW, while the consumption of Circuit B is 53.9 kW at identical conditions.
- 2. The COP of Circuit A is 4.9 (0.7 kW/RT) whereas COP is only 2.5 (1.4 kW/RT) for Circuit B.

- 3. Condensing pressure in **circuit A is 317 psi(g)** and **B is 567 psi(g)** which corresponds to condensing temperature (labelled as "Ref Cond Midpoint A and B) increased from **99.9F to 146F a 44.6F DT.**

- 4. Discharge temperature measured with three different sensors at **Circuit A is near 150F** and **Circuit B is near 218F** also a result of the higher-pressure ratio and the higher condensing pressure.

- 5. Liquid temperature at expansion valve inlet for **Circuit A is 79F** and for **Circuit B 113F**. The difference is **34F** whereas the difference in condensing temperature between circuits is **44.6F** (noted in bullet 3 99.9F to 146F).

- 6. Circuit A has a sub cool of 21 F and Circuit B of 31F. The latter is a high level of sub cool corresponding to liquid build up blocking a significant part of condenser surface.

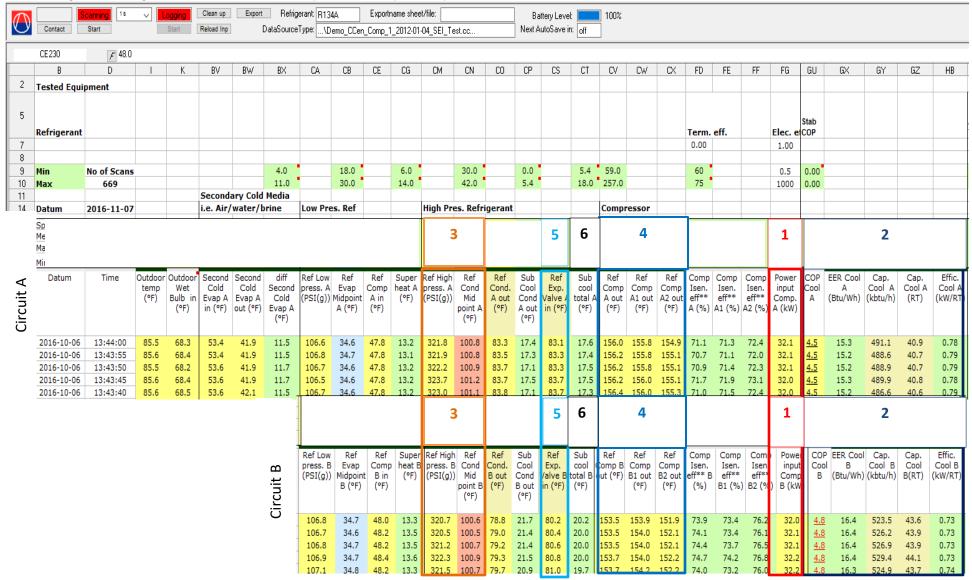
Figure 5 Report Page Circuit A and B October 6, 2016

In the following figure 5, we are showing you the same parameters as above to show you a straight comparison as to how the chiller is now operating versus how it was running during our first test.

• Circuit B behaves nearly identical to Circuit A on all measured values and performance.

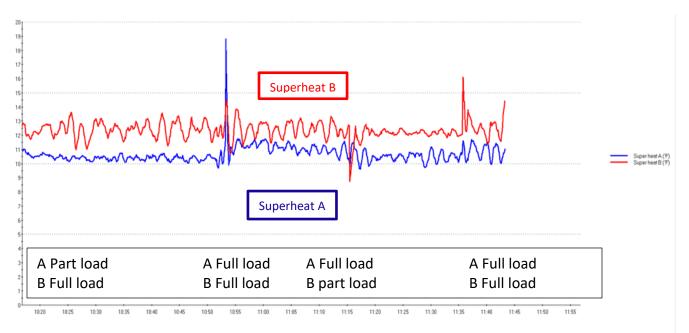
Figure 6 Superheat on Circuits A and B – Mar 2016

In our first measurement whether one compressor was running or two the superheat on circuit B was relatively higher than the superheat on circuit A, as shown in **Figure**.

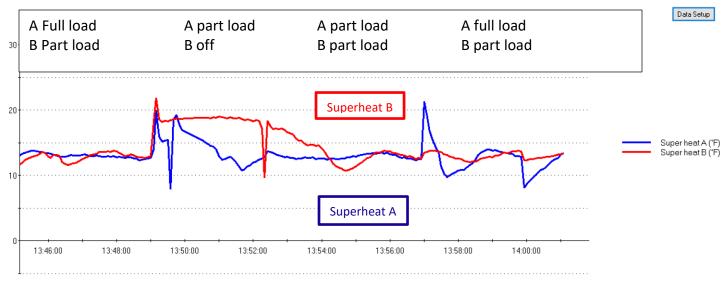
Figure 7 Superheat on Circuits A and B – Oct 2016

After maintenance, the superheat remains similar and within expected range as seen in **Error! Reference** source not found.

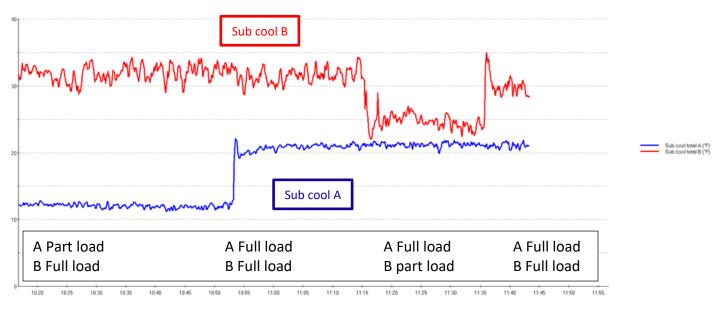
Figure 8 Sub cool on Circuit A and B – March 2016

As **figure 8** shows, the sub cool on circuit A is within range whereas the sub cool on circuit B is higher than the recommended range which is a result of high refrigerant levels in the condenser. The high refrigerant level in this case was caused by the low air flow creating a high dT between incoming air and liquid refrigerant.

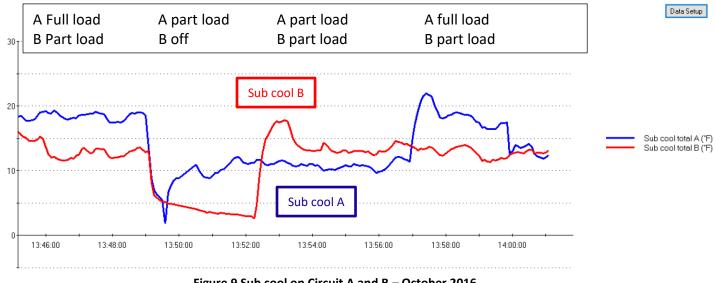
Figure 9 Sub cool on Circuit A and B – October 2016

The excess Sub-cool of circuit B which was more than 10F higher than circuit A at full load has disappeared after fan contactor/fuse was repaired. At full load circuit A has 17-19 F of Sub-cool and circuit B has 12-14 F at part load. Circuit B is now within expected range. See figure 9
