**Banner Desert Medical Center**

**RE: ClimaCheck chiller testing Banner Desert**

Banner Medical - Phoenix  
York YK Chiller Test Results  
June 2015

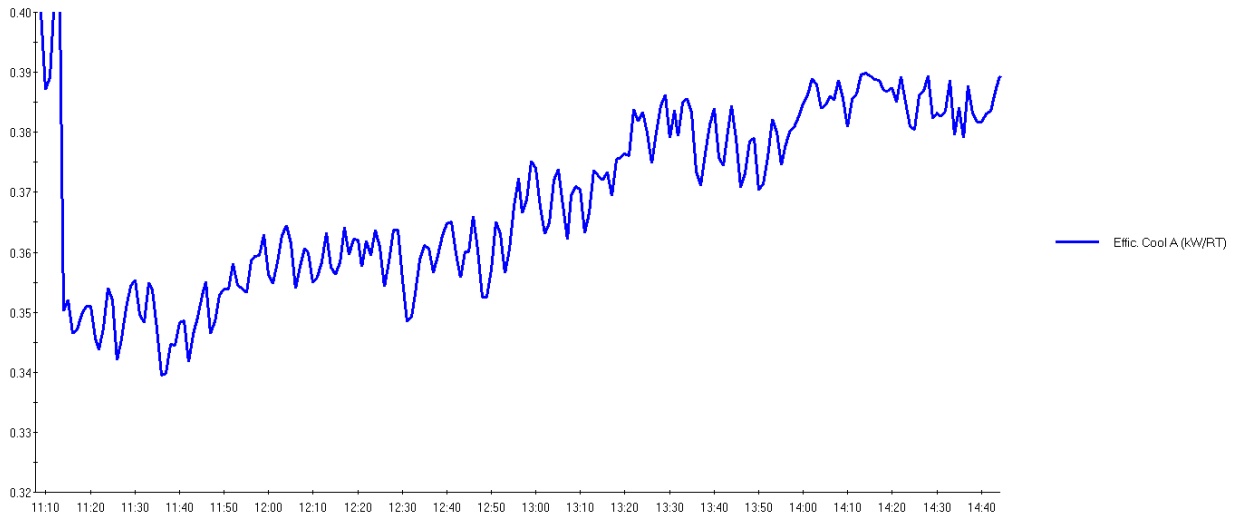
Banner Desert - Chiller 3 - kW/ton Fluctuations - May 13, 2015

- Chiller 3 is the highest priority for maintenance, mostly in the evaporator:
  - The compressor shows some degradation but it is still a high isentropic efficiency (~63%).

Replace the control board on Chiller 3 and ensure its control algorithm is tuned to keep the inlet vanes fully open while slowing down the VFD speed.
