ViaSat 6155 El Camino Real Carlsbad, CA 92009 Trane CGAM Chiller Performance Analysis Oct 2016

Tests done by: Sean McCaffery, Emerging Energy Solutions Report published by: Klas Berglof, ClimaCheck Sweden AB

Executive Summary

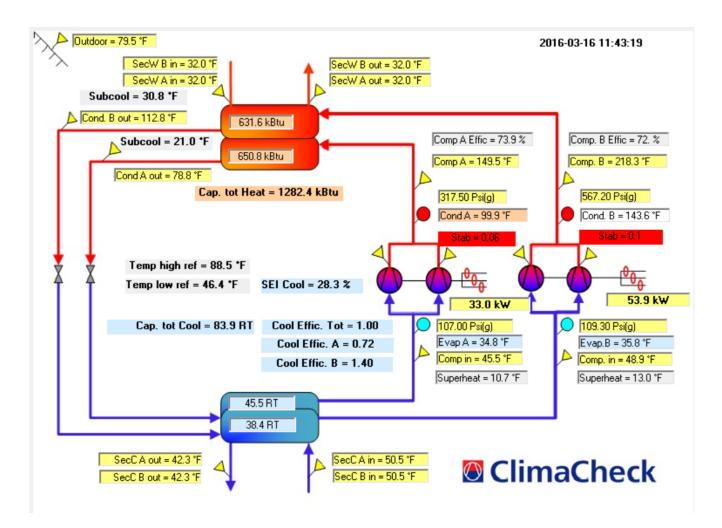
Figure 1 Chiller flowchart

The air-cooled Trane CGAM chiller consists of two circuits with two scroll compressors on each circuit without heat recovery, oil cooler or economizer. All four compressors are identical.

The two circuits are hereafter referred to as Circuit A and Circuit B while the compressors are referred to as compressor A1, A2 (on circuit A) – B1 and B2 (on circuit B). This corresponds with the circuits labelled in the chiller as Circuit 1 (A) and Circuit 2 (B).
